## Root Cause Analysis Report

### Interstate 5 Skagit River Bridge Collapse - Sept. 2016 Update

Report Number	WA12.684	RCA Owner	Cory Boisoneau
Report Date	1/9/2014	RCA Facilitator	Cory Boisoneau

## Focal Point: Bridge Collapse

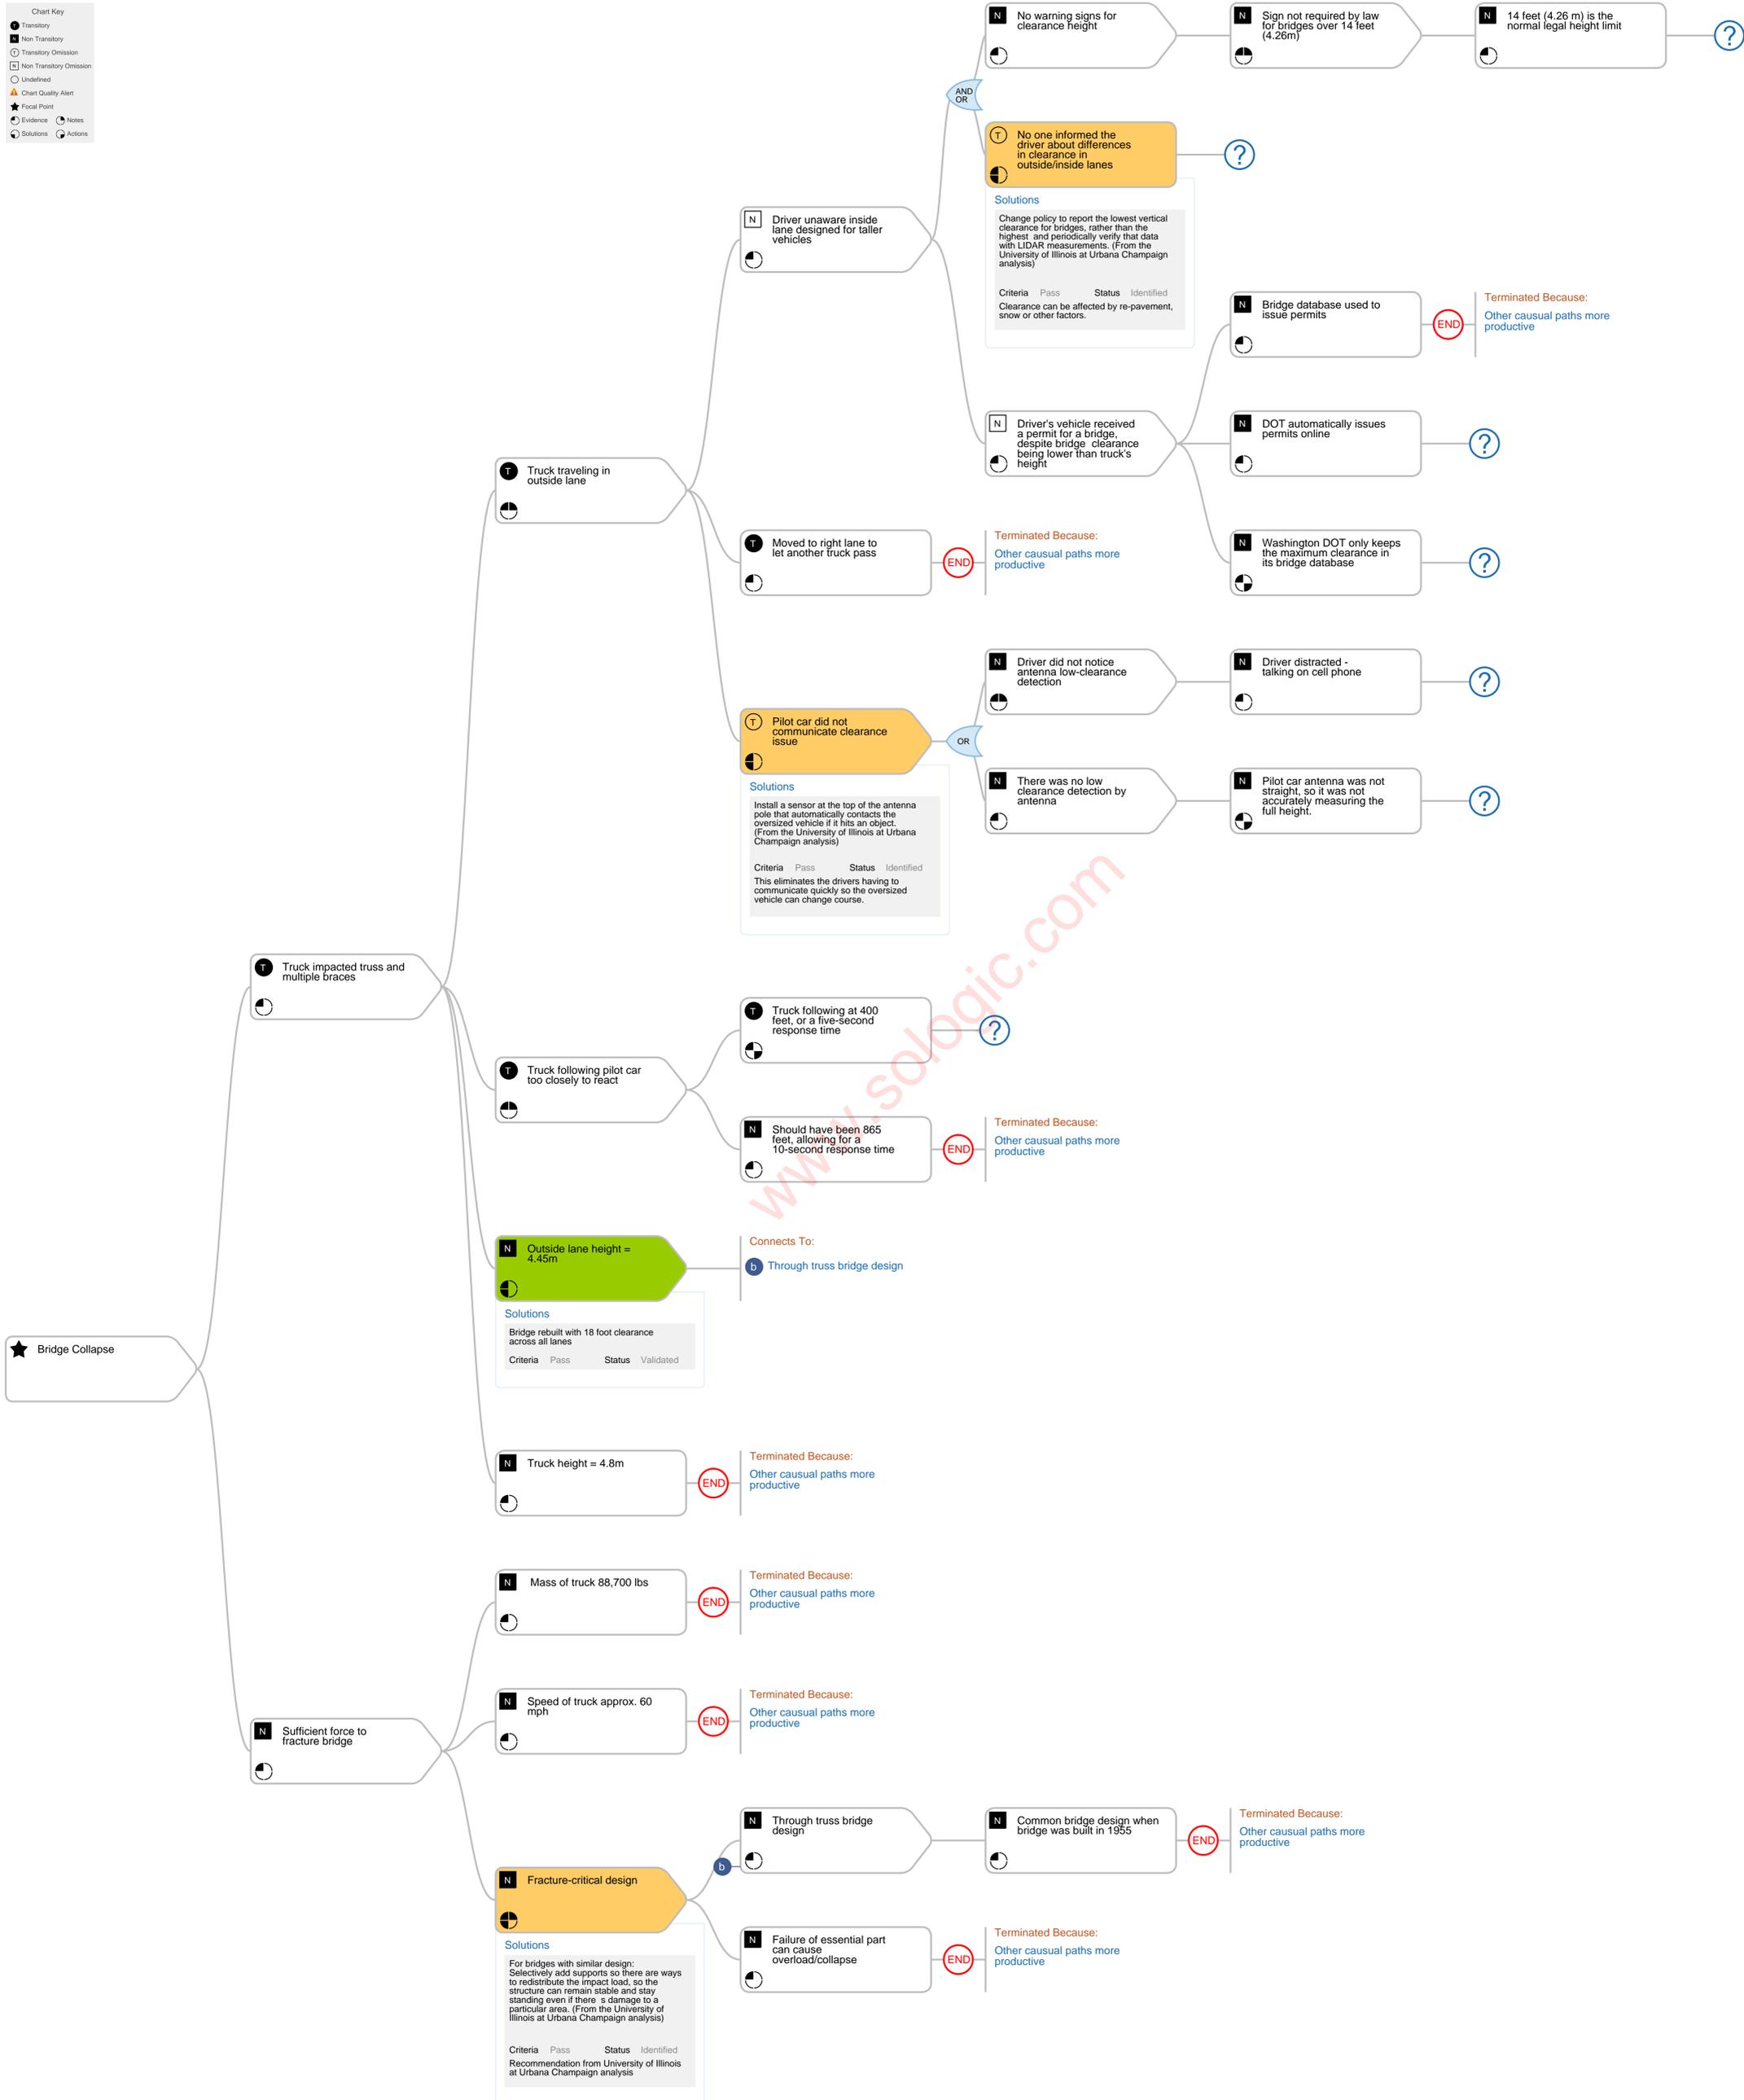
Chart Key

The bridge collapse was caused by a semi truck impacting a truss and multiple braces with sufficient force to fracture the bridge. The truck impacted the truss and multiple braces because it was traveling in the outside lane which was shorter in height than the inside lane. The truck was traveling in outside lane because the driver was unaware that the inside lane was designed for taller vehicles, he moved to right lane to let another truck pass, and the pilot car did not communicate the clearance issue. The driver was unaware of the lane height differences because his vehicle received a permit for the route, despite this particular bridge clearance being lower than the truck's height, there were no warning signs for clearance height, and no one informed the driver about differences in clearance in outside/inside lanes. The vehicle received a permit for a bridge, despite bridge clearance being lower than truck's height because the DOT automatically issues permits online, Washington DOT only keeps the maximum clearance in its bridge database, and a bridge database is used to issue permits. There were no warning signs for the clearance height because signage is not required by law for bridges over 14 feet (4.26m). The pilot car did not communicate clearance issues because the pilot car driver did not notice the antenna low-clearance detection, or because there was no low clearance detection by antenna (unclear which was the case). Regardless, the truck was following the pilot car too closely to react, even if escort had noticed and communicated. The driver did not notice the potential antenna low-clearance detection because the driver was distracted - talking on cell phone. There was potentially no low clearance detection by the antenna because the antenna was not straight, so it was not accurately measuring the full height. There was sufficient force to fracture the bridge because the mass of the truck was 88,700 lbs, its speed was approximately 60 mph, and the bridge was built using a fracture-critical, through truss design. Fracture-critical design means that failure of an essential part can cause overload/collapse. A through truss bridge design was used because it was a common bridge design when bridge was built in 1955.
