Problem Statement

| Report Number | RCA-26-10-2017-214 | RCA Owner | Chris Eckert |

Focal Point: West Point Treatment Plant Incident

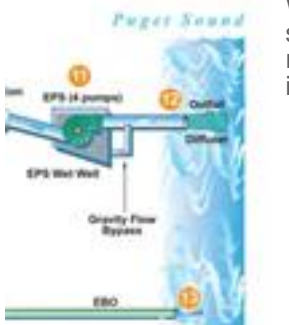
The EPS wet well water level begins to rise.

With the Effluent Pumps shut down, water begins to rise immediately upstream in the EPS wet well.

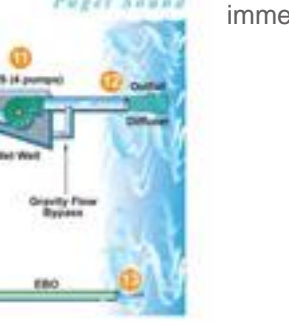
Electrical fault occurred

Effluent Pumps 1 & 2 immediately shut down
