Problem Statement

Report Number	Example	RCA Owner	Brian Hughes
Report Date	6/19/2015	RCA Facilitator	Brian Hughes

Focal Point: Potential injury/fatality to patient and/or staff - loss of equipment 5 days

After a ferrous oxygen bottle was pulled into the magnet of an MRI scanner when patient and staff were in the magnet room.

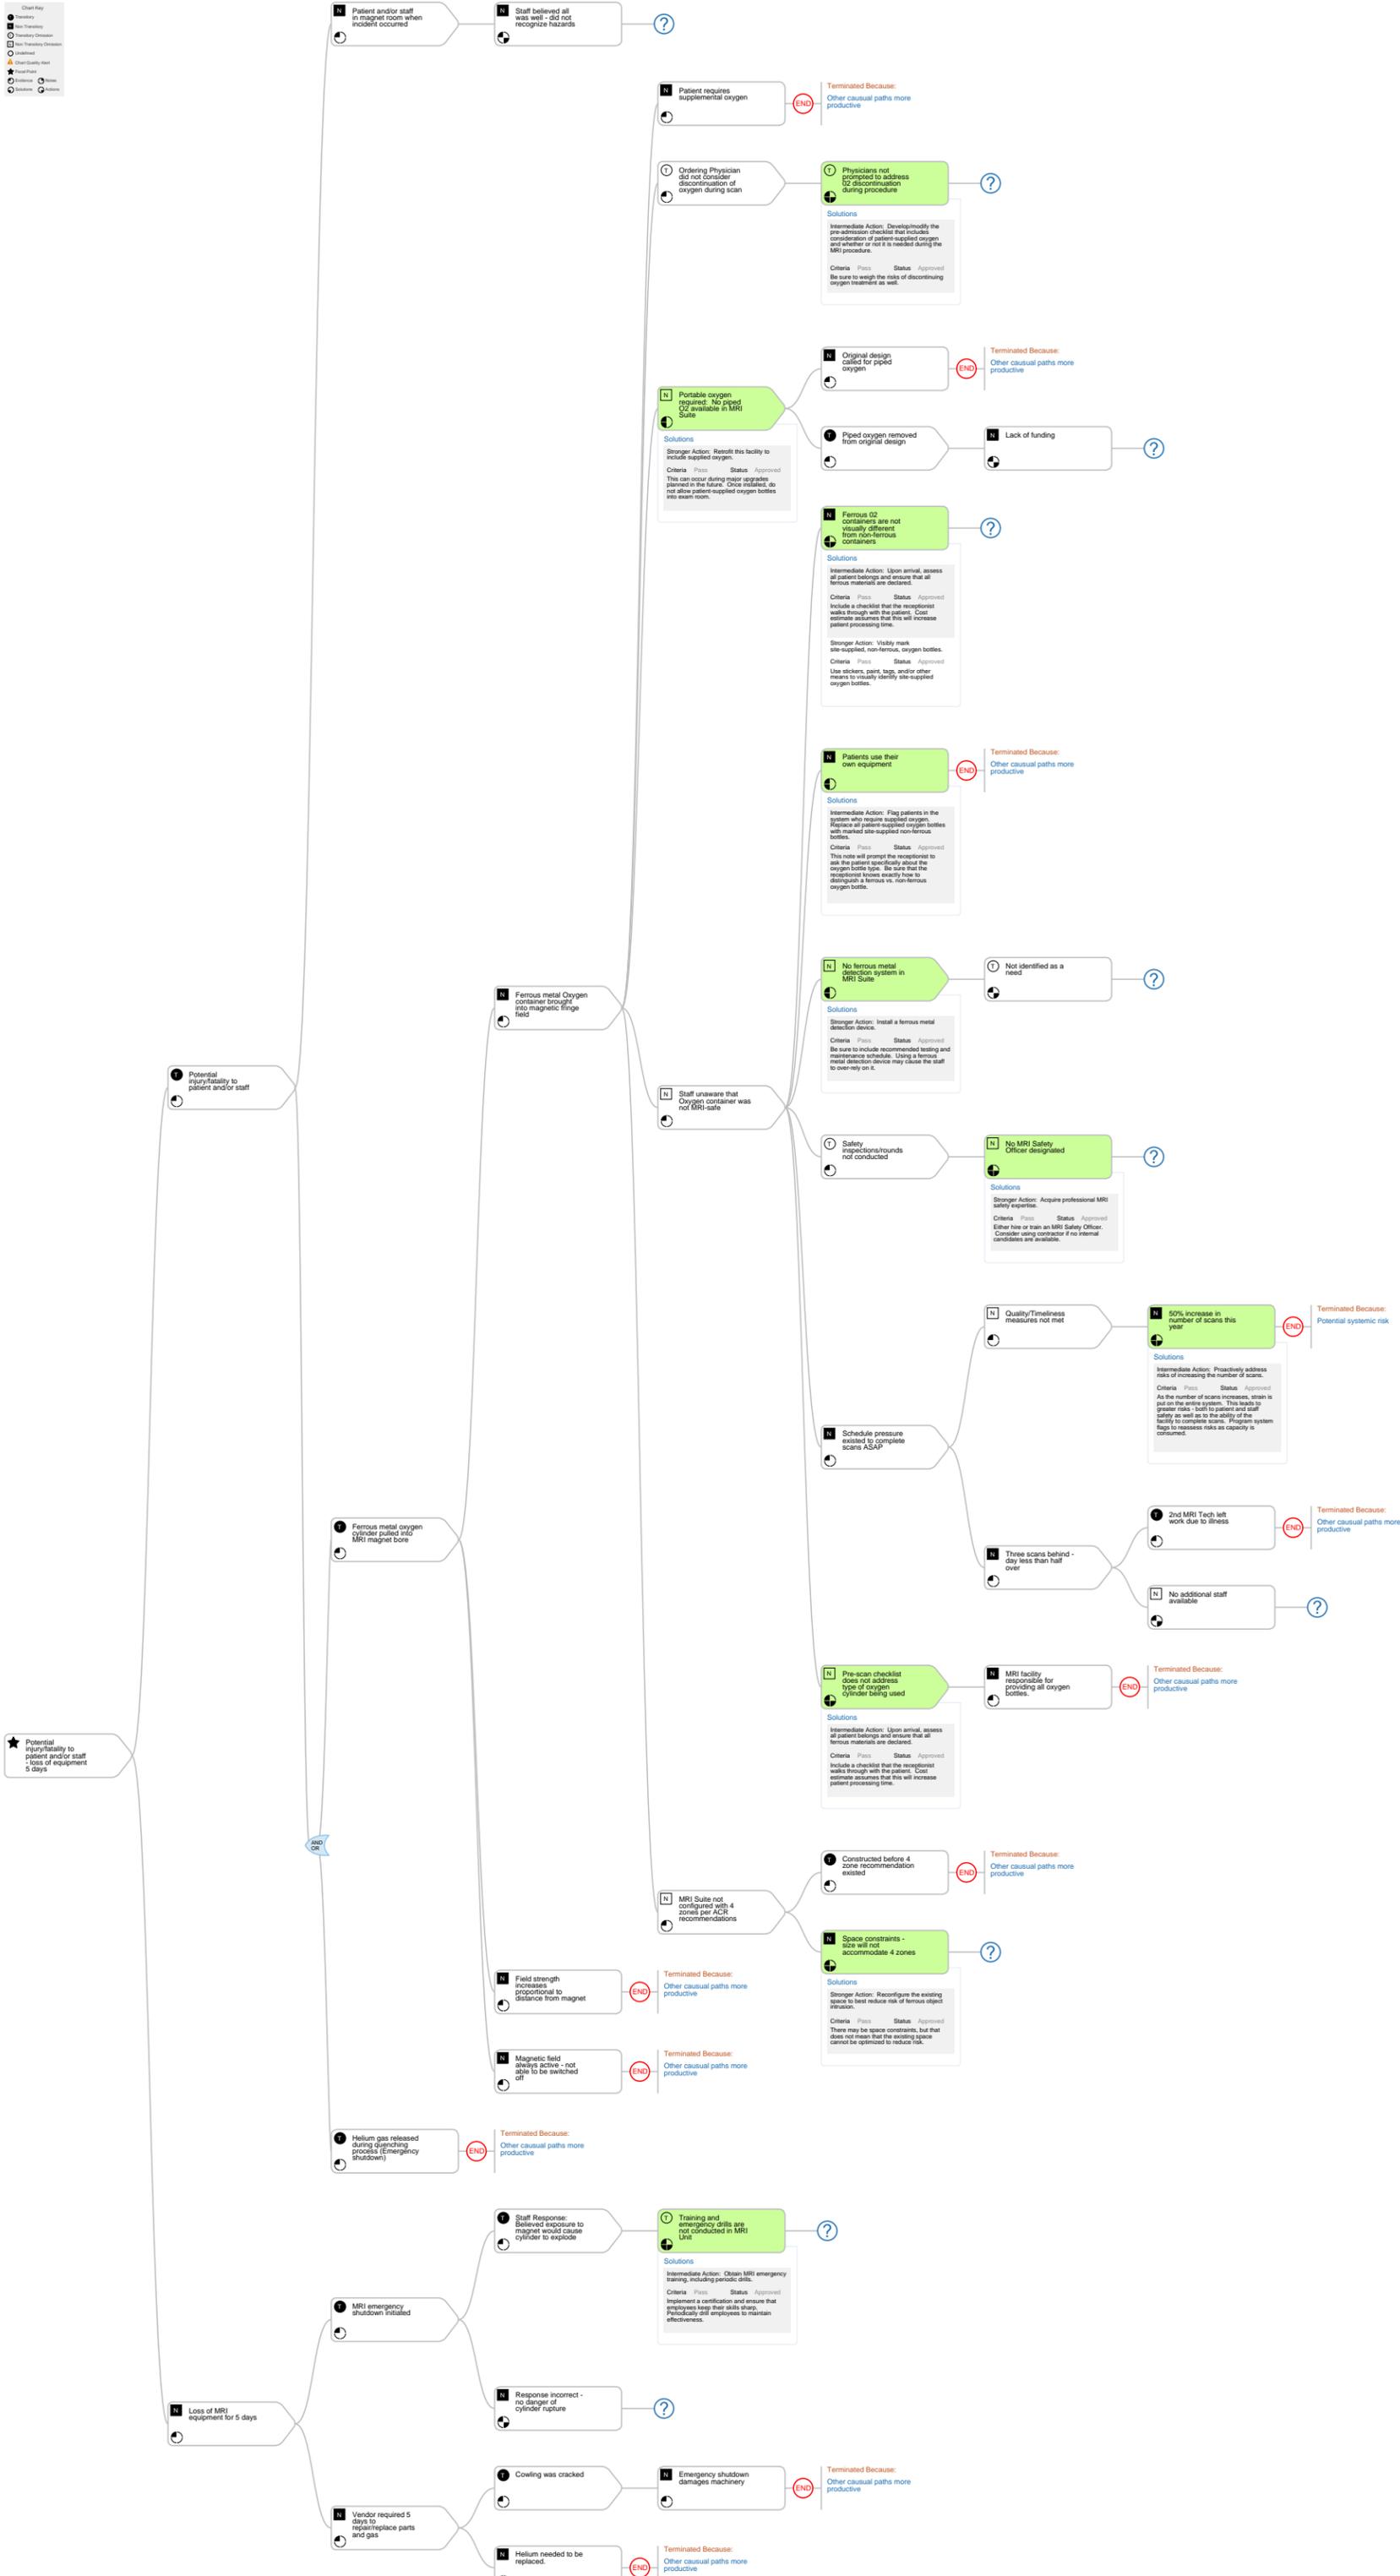
Recently an MRI center experienced a near-miss event when a ferrous oxygen bottle was pulled into the magnetic bore of an MRI machine. The patient and staff were present in the magnet room at the time of the event. They were not in the line of fire between the oxygen cylinder and the magnet, and therefore were not struck by the flying cylinder. They were also exposed to, but not injured by, helium gas released when a staff member initiated emergency shutdown (also called “quenching”) of the magnet. A risk assessment determined that this was a potentially catastrophic (SAC Matrix score = 3) event, which could have resulted in serious injury and/or fatality.

The staff initiated an emergency shutdown because they were concerned that the oxygen bottle would rupture or explode. This assumption was incorrect – bottle-rupture was not a risk. The staff has not been trained in MRI

emergency response. No emergency drills are conducted. There is also no designated MRI Safety Officer.

The emergency shutdown damaged the MRI machine, requiring five days to repair. No scans were completed during this time.

The patient was admitted to the magnet room with his own bottle of supplemental oxygen. This bottle was made from ferrous material. The staff utilizes a pre-scan checklist to identify ferrous items, but this list does not address supplemental oxygen bottles. The facility normally would supply non-ferrous oxygen bottles to patients for the duration of their visit, but confusion during check-in caused them to miss this one. Compounding the issue, ferrous oxygen bottles look very similar to non-ferrous bottles, which makes them difficult to visually identify. By the time the patient was ready to enter the magnet room, the staff assumed that all ferrous objects had been accounted for and removed.

There is no ferrous metal detection system in the MRI suite. The Ordering Physician did not consider whether the patient could discontinue supplemental oxygen during the MRI procedure. And the facility is not configured with four progressively safer zones per ACR recommendations. It was constructed prior to the four-zone recommendation and existing space constraints preclude it from being reconfigured.

The staff was very busy during the admission procedure for this patient - they were three scans behind schedule and were trying to catch up. A second MRI technician had to leave work due to illness. No additional staff was available to replace the sick technician. At the time, the facility was not meeting target quality/timeliness metrics. It has experienced a 50% increase in number of scans conducted this year. Managing this growth has proved to be challenging. This growth represents a potential systemic risk that should be examined further in a separate investigation.
