Problem Statement

| Report Number | RCA-26-10-2017-214 | RCA Owner | Chris Eckert |

Focal Point: West Point Treatment Plant Incident

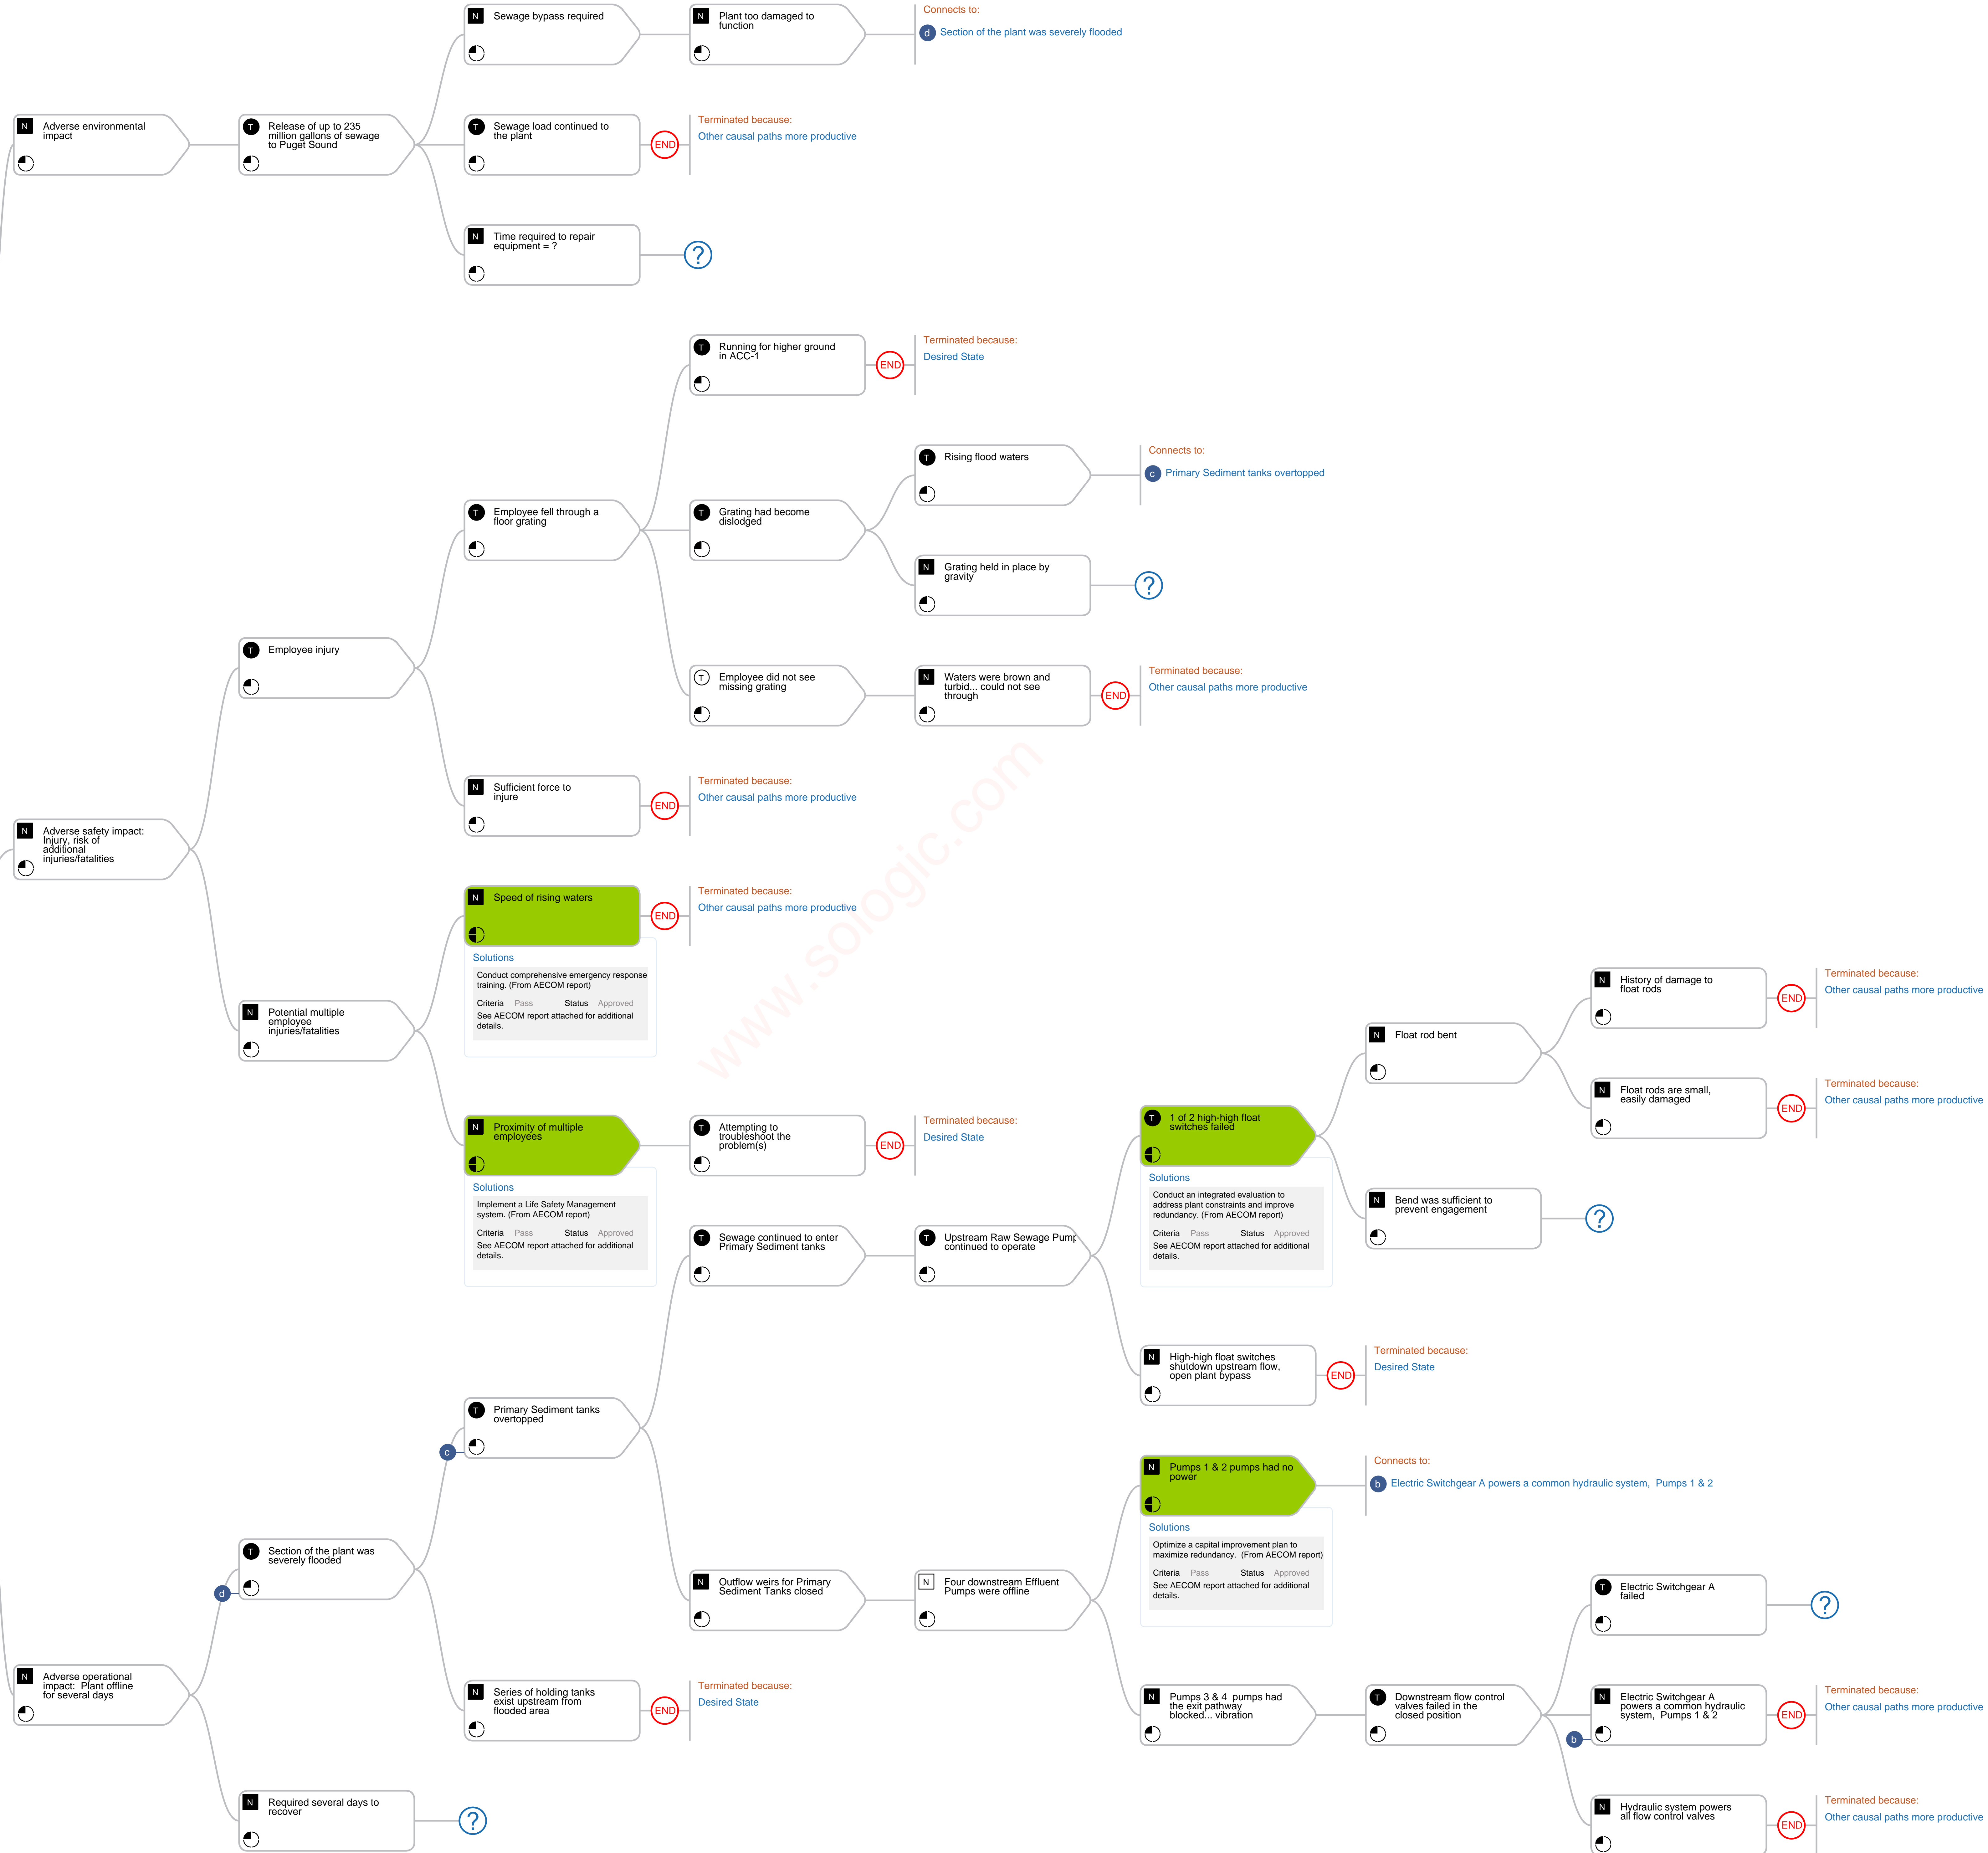
★ West Point Treatment Plant Incident

On this night, the plant was operating near capacity when an electrical fault shut power down to part of the plant, including Effluent Discharge Pumps 1 & 2 as well as a hydraulic system which was the single source of hydraulic power to Effluent Flow Control valves. The plant uses a total of four Effluent Discharge Pumps, but only at high tide. At low tide, the pumps are not needed. When the hydraulic system lost power, the valves (by design) failed to the closed position. Of the four total Effluent Discharge Pumps, at the time of the power loss, pumps 2, 3, & 4 were operating while pump 1 was in standby mode. Effluent Pump 2 shut down when it lost power. And Effluent Pumps 3 & 4, pumping against the closed flow control valves, experienced high vibration, which caused them to shut down shortly thereafter. At this point, very little effluent is able to flow out of the plant. Yet millions of gallons are still flowing in.

When the Effluent Flow Pumps shut down, effluent began building up immediately upstream in the Effluent Pump Station (EPS) wet well until the EPS high-high indicator triggered. This caused weir gates to close upstream in the Primary Sedimentation tanks, stopping flow at that point. But then the Primary Sedimentation Tanks began to fill. These tanks are equipped with two high-high float switches which shut down the upstream Raw Sewage Pumps and open the system bypass. However, one of them did not function properly due to a bent float rod. These switches have a history of failure. The rods are easily bent, which then prevents the floats from tripping the switch.

were unaware that the flow control valves downstream from the Effluent Discharge Pumps had failed closed due to no hydraulic power. And they also did not realize that the weir gates on the Primary Sedimentation Tanks had been closed (and locked in place) by the high-high safety switch in the Effluent Pump Station wet well. And there were so many alarms (2,100 in an hour) that the operators in the Control Room were simply overwhelmed with information.
